REPORT NUMBER: 201U-CAL-05-04

**SAFETY COMPLIANCE TESTING FOR FMVSS 201
OCCUPANT PROTECTION IN INTERIOR IMPACT
UPPER INTERIOR HEAD IMPACT PROTECTION**

**GENERAL MOTORS OF CANADA LTD.
2005 BUICK LACROSSE 4-DOOR SEDAN**

NHTSA NUMBER: C50104

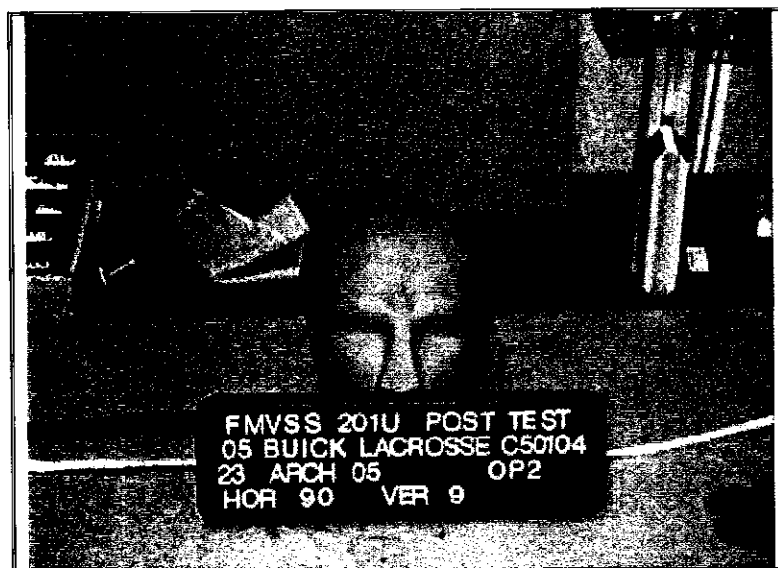
POST-IMPACT OP2 HEADFORM

Test Number:	01
Test Date:	03/23/05
Target Location:	Other Pillar
Target Code:	OP2
Horizontal Impact Angle:	90°
Vertical Impact Angle:	9°
Ambient Temperature:	24.2C°
Relative Humidity:	13.9
Time of Impact:	9:20
Headform Number:	62

Impact Point Description (from lower midpoint on midsagittal line)				
On Centerline	2	<input type="checkbox"/>	mm right	<input checked="" type="checkbox"/> mm left
On Centerline	21		mm up

Free Motion HIC	801.5
HIC(d)	771.1
Impact Velocity (kph)	23.54
HIC T1 (msec)	4.3
HIC T2 (msec)	10.6

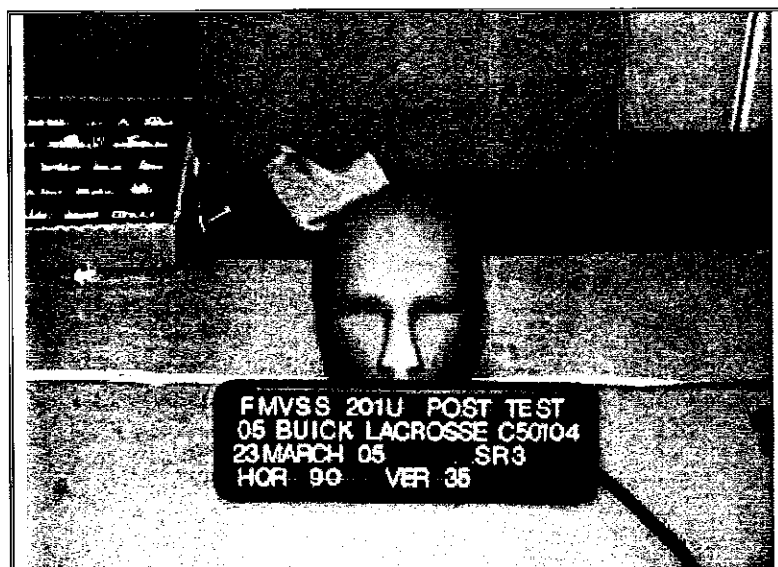
POST-IMPACT SR3 HEADFORM

Test Number:	02
Test Date:	03/23/05
Target Location:	Side Rail
Target Code:	SR3
Horizontal Impact Angle:	90°
Vertical Impact Angle:	35°
Ambient Temperature:	24.3C°
Relative Humidity:	13.9
Time of Impact:	9:50
Headform Number:	355

Impact Point Description (from lower midpoint on midsagittal line)			
On Centerline	6	<input type="checkbox"/> mm right	<input checked="" type="checkbox"/> mm left
On Centerline	14	mm up

Free Motion HIC	781
HIC(d)	755.6
Impact Velocity (kph)	23.36
HIC T1 (msec)	2.9
HIC T2 (msec)	8.8

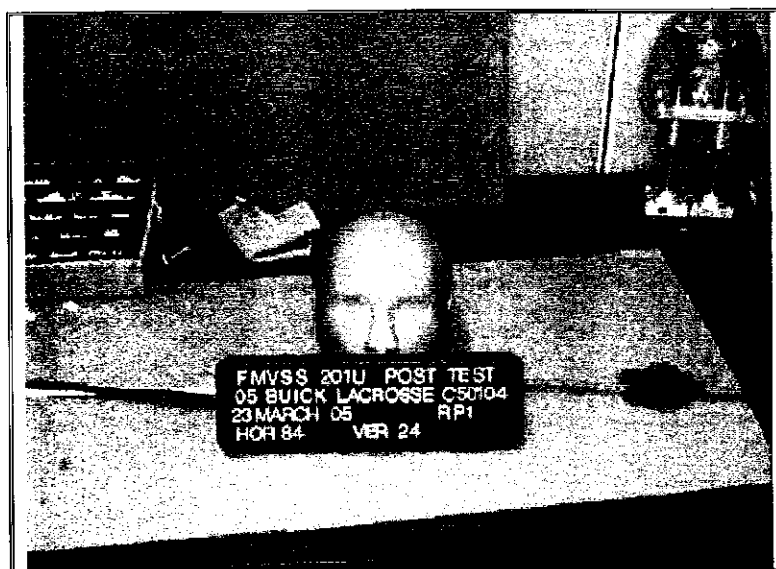
POST-IMPACT RP1 HEADFORM

Test Number:	03
Test Date:	03/23/05
Target Location:	Rear Pillar
Target Code:	RP1
Horizontal Impact Angle:	84°
Vertical Impact Angle:	24°
Ambient Temperature:	24.5C°
Relative Humidity:	14.2
Time of Impact:	10:25
Headform Number:	805

Impact Point Description (from lower midpoint on midsagittal line)			
On Centerline	15	<input type="checkbox"/> mm right	<input checked="" type="checkbox"/> mm left
On Centerline	10	mm up

Free Motion HIC	775.5
HIC(d)	751.5
Impact Velocity (kph)	23.66
HIC T1 (msec)	1.6
HIC T2 (msec)	7.7

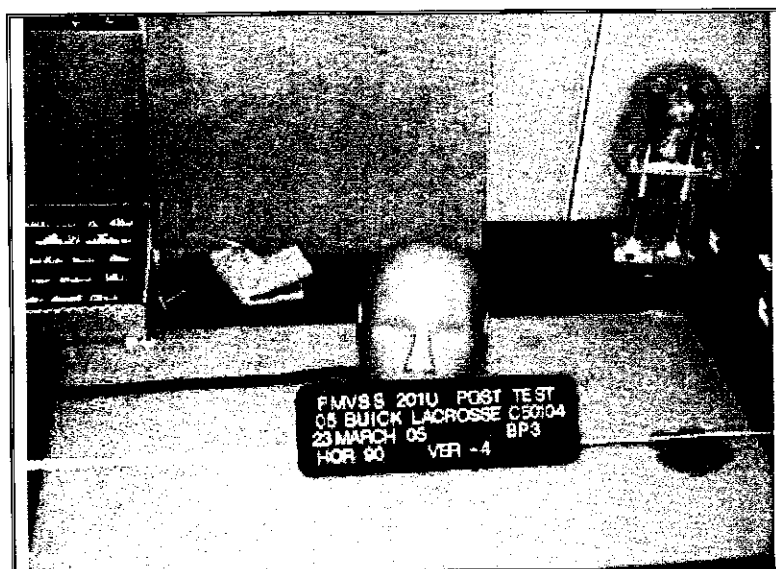
POST-IMPACT BP3 HEADFORM

Test Number:	04
Test Date:	03/23/05
Target Location:	B-Pillar
Target Code:	BP3
Horizontal Impact Angle:	90°
Vertical Impact Angle:	-4°
Ambient Temperature:	23.8C°
Relative Humidity:	13.8
Time of Impact:	10:45
Headform Number:	1255

Impact Point Description (from lower midpoint on midsagittal line)			
On Centerline	45	<input checked="" type="checkbox"/> mm right	<input type="checkbox"/> mm left
On Centerline	10	mm up

Free Motion HIC	350.1
HIC(d)	430.5
Impact Velocity (kph)	23.64
HIC T1 (msec)	2.6
HIC T2 (msec)	12.5

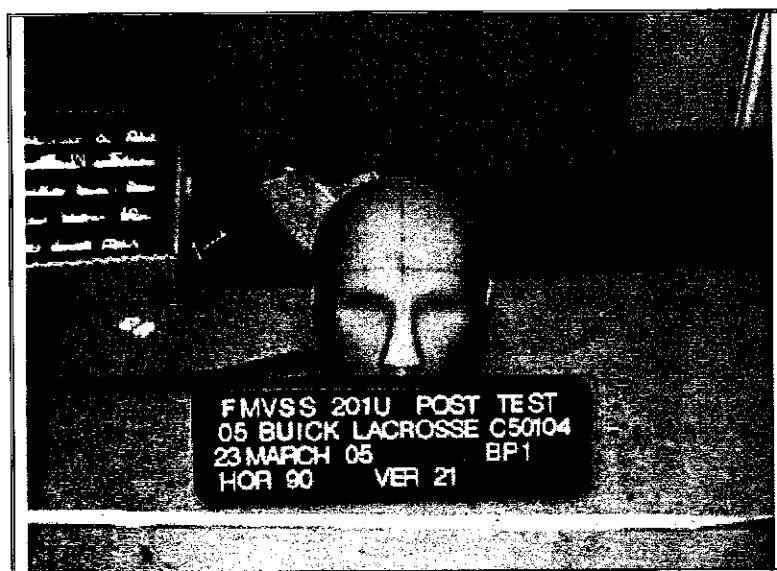
POST-IMPACT BP1 HEADFORM

Test Number:	05
Test Date:	03/23/05
Target Location:	B-Pillar
Target Code:	BP1
Horizontal Impact Angle:	90°
Vertical Impact Angle:	21°
Ambient Temperature:	24.3C°
Relative Humidity:	13.4
Time of Impact:	11:25
Headform Number:	642

Impact Point Description (from lower midpoint on midsagittal line)			
On Centerline	5	<input checked="" type="checkbox"/> mm right	<input type="checkbox"/> mm left
On Centerline	8	mm up

Free Motion HIC	711.2
HIC(d)	703
Impact Velocity (kph)	23.72
HIC T1 (msec)	2.4
HIC T2 (msec)	9.3

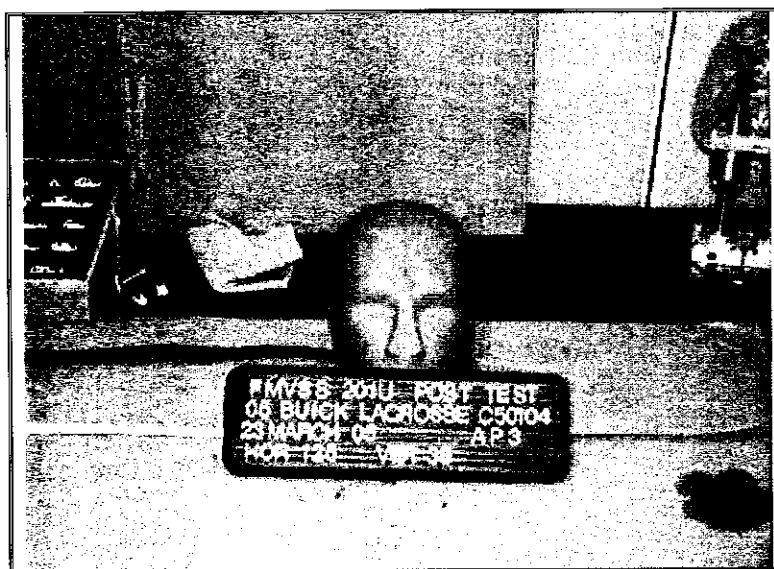
POST-IMPACT AP3 HEADFORM

Test Number:	06
Test Date:	03/23/05
Target Location:	A-Pillar
Target Code:	AP3
Horizontal Impact Angle:	125°
Vertical Impact Angle:	38°
Ambient Temperature:	24.5C°
Relative Humidity:	13.7
Time of Impact:	13:20
Headform Number:	62

Impact Point Description (from lower midpoint on midsagittal line)				
On Centerline	6	<input checked="" type="checkbox"/>	mm right	<input type="checkbox"/> mm left
On Centerline	20		mm up

Free Motion HIC	668.1
HIC(d)	664.9
Impact Velocity (kph)	23.89
HIC T1 (msec)	1.7
HIC T2 (msec)	7.2

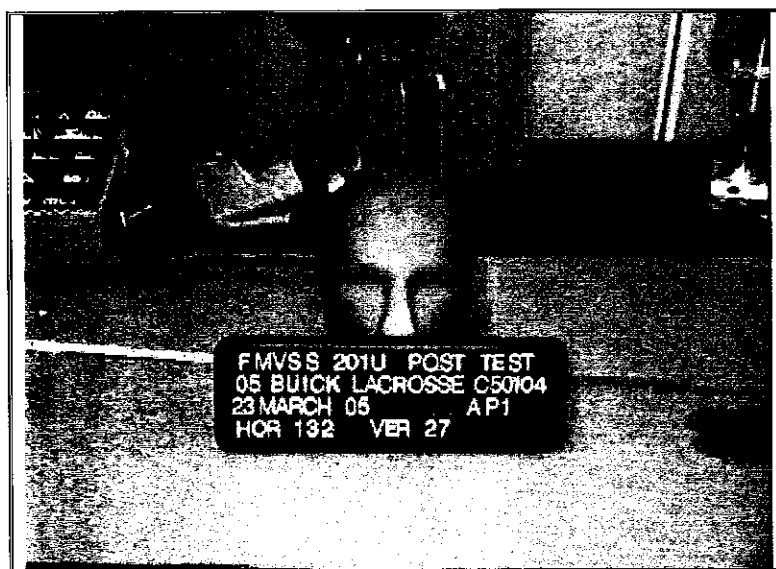
POST-IMPACT AP1 HEADFORM

Test Number:	07
Test Date:	03/23/05
Target Location:	A-Pillar
Target Code:	AP1
Horizontal Impact Angle:	132°
Vertical Impact Angle:	27°
Ambient Temperature:	24.6C°
Relative Humidity:	14.6
Time of Impact:	13:55
Headform Number:	355

Impact Point Description (from lower midpoint on midsagittal line)			
On Centerline	35	<input checked="" type="checkbox"/> mm right	<input type="checkbox"/> mm left
On Centerline	28	mm up

Free Motion HIC	641.7
HIC(d)	650.5
Impact Velocity (kph)	23.46
HIC T1 (msec)	2.3
HIC T2 (msec)	7.7

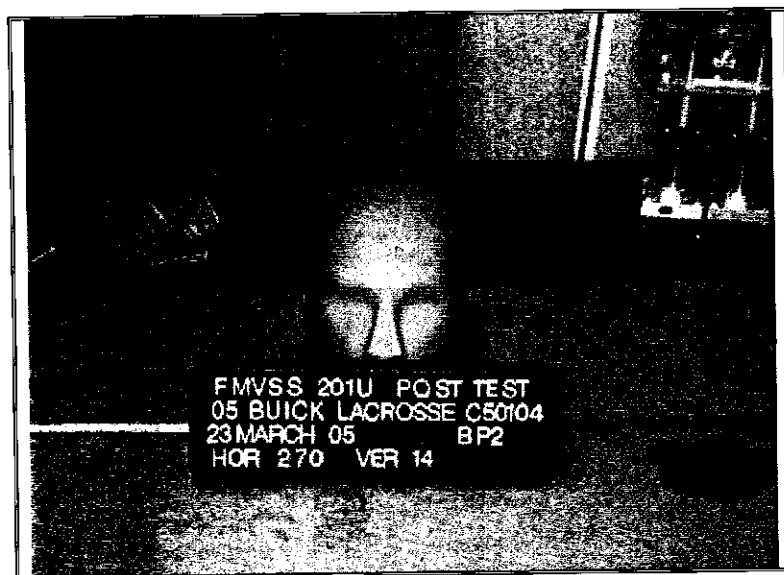
POST-IMPACT BP2 HEADFORM

Test Number:	08
Test Date:	03/23/05
Target Location:	B-Pillar
Target Code:	BP2
Horizontal Impact Angle:	270°
Vertical Impact Angle:	14°
Ambient Temperature:	24.6C°
Relative Humidity:	16.7
Time of Impact:	15:30
Headform Number:	805

Impact Point Description (from lower midpoint on midsagittal line)			
On Centerline	17	<input type="checkbox"/> mm right	<input checked="" type="checkbox"/> mm left
On Centerline	12	mm up

Free Motion HIC	933.9
HIC(d)	871.0
Impact Velocity (kph)	23.83
HIC T1 (msec)	1.9
HIC T2 (msec)	7.4

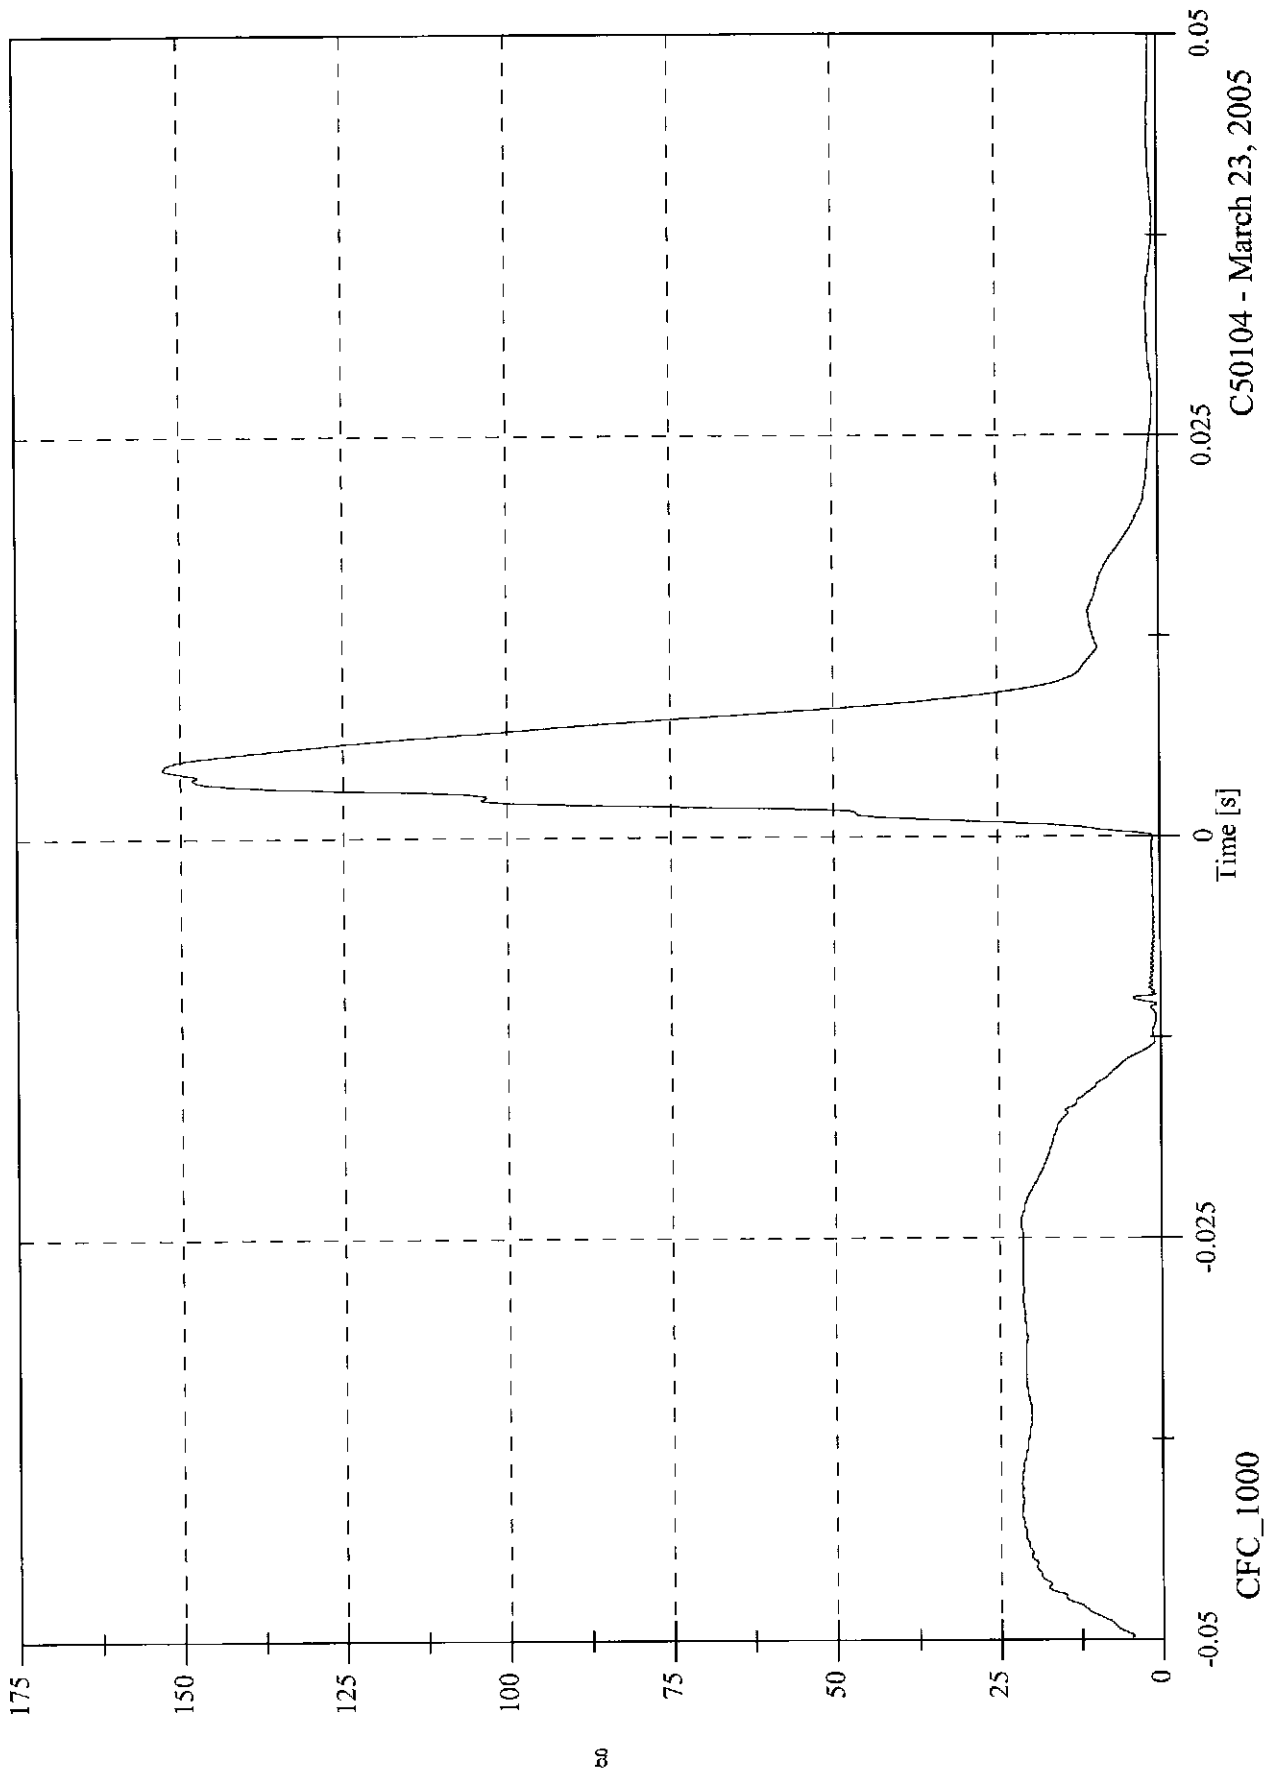
Headform Resultant

Max: 152.8 [g] at 0.004 [s]
Min: 0.6 [g] at -0.010 [s]

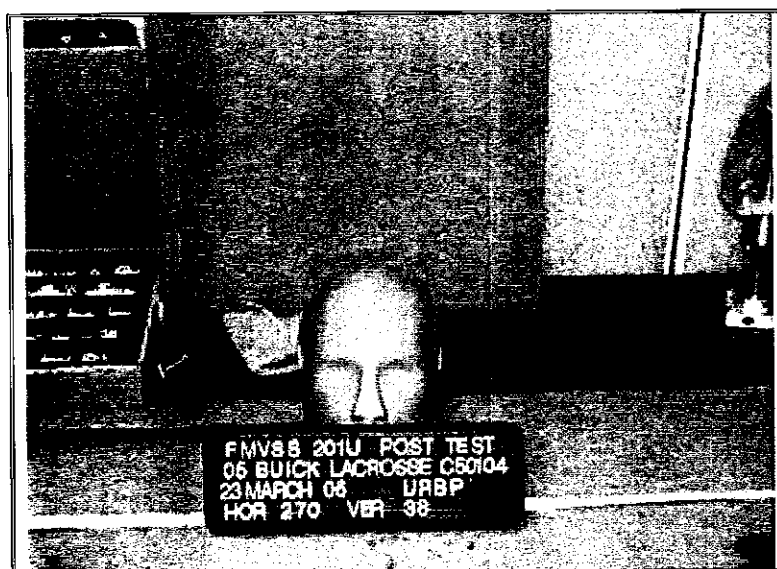
POST-IMPACT URBP HEADFORM

The selected impact areas on the test vehicle appeared to comply with the performance requirements of FMVSS 201 with the exception of URBP impact area.

Test Number:	09
Test Date:	03/23/05
Target Location:	Upper Roof
Target Code:	URBP
Horizontal Impact Angle:	270°
Vertical Impact Angle:	38°
Ambient Temperature:	24.4C°
Relative Humidity:	17
Time of Impact:	16:15
Headform Number:	1255

Impact Point Description (from lower midpoint on midsagittal line)			
On Centerline	15	mm right	x mm left
On Centerline	58	mm up

Free Motion HIC	1233.1
HIC(d)	1096.7
Impact Velocity (kph)	23.6
HIC T1 (msec)	3.1
HIC T2 (msec)	7.7

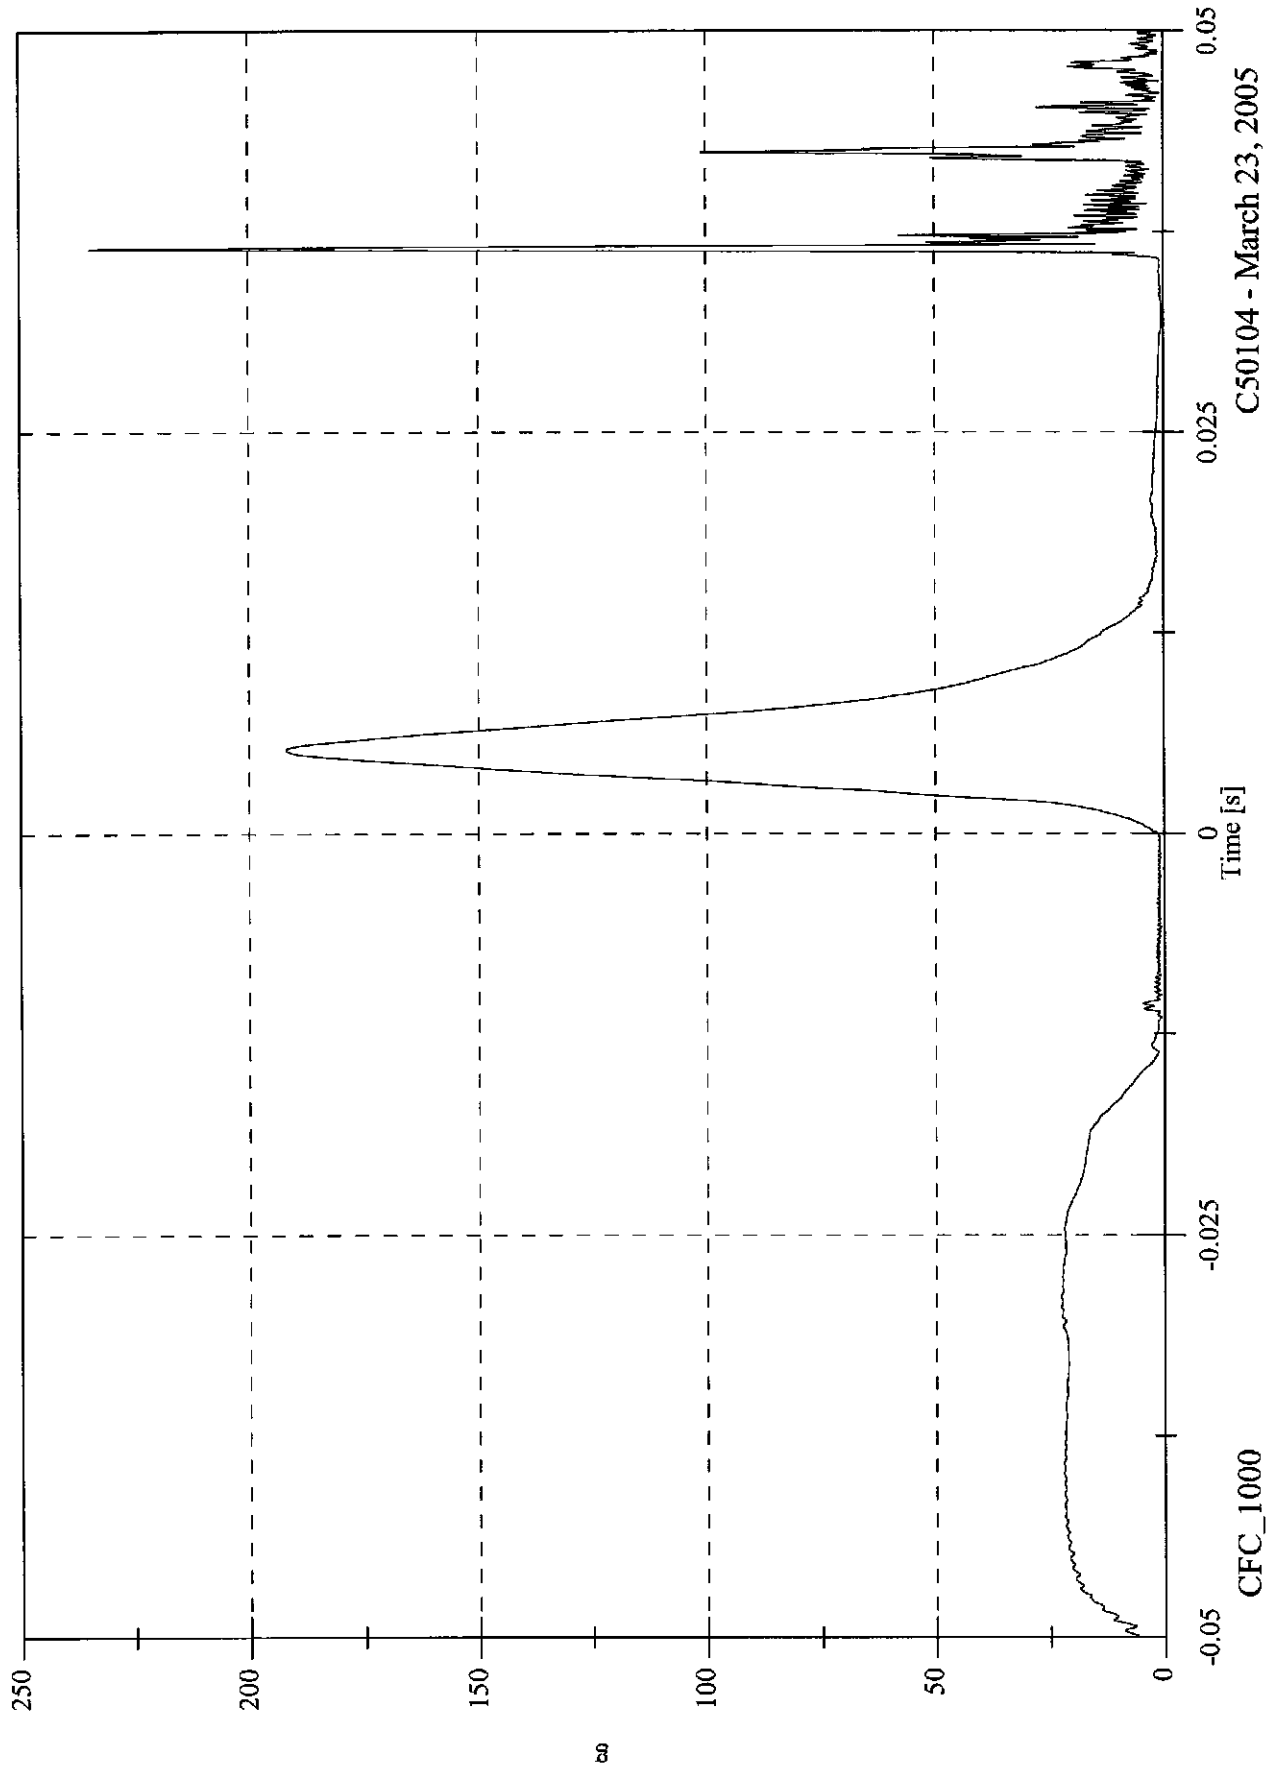
Max: 234.7 [g] at 0.036 [s]
Min: 0.4 [g] at 0.032 [s]

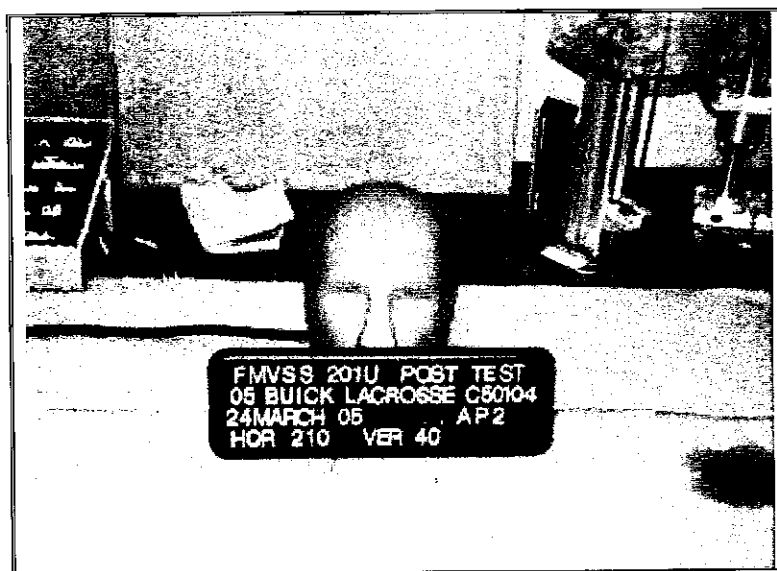
POST-IMPACT AP2 HEADFORM

Test Number:	10
Test Date:	03/24/05
Target Location:	A-Pillar
Target Code:	AP2
Horizontal Impact Angle:	210°
Vertical Impact Angle:	40°
Ambient Temperature:	24.3C°
Relative Humidity:	19.5
Time of Impact:	9:20
Headform Number:	355

Impact Point Description (from lower midpoint on midsagittal line)			
On Centerline	24	<input checked="" type="checkbox"/> mm right	<input type="checkbox"/> mm left
On Centerline	35	mm up

Free Motion HIC	800.1
HIC(d)	770.1
Impact Velocity (kph)	23.72
HIC T1 (msec)	4.9
HIC T2 (msec)	8.1

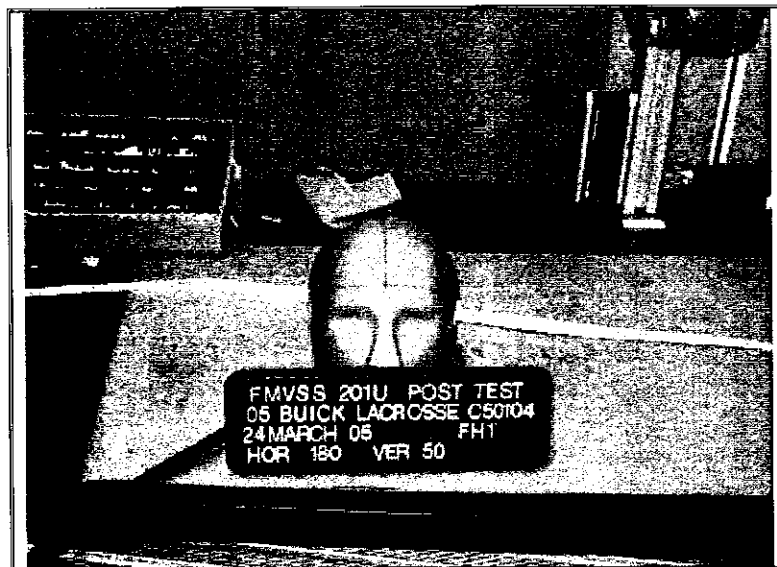
POST-IMPACT FHI HEADFORM

Test Number:	11
Test Date:	03/24/05
Target Location:	Front Header
Target Code:	FH1
Horizontal Impact Angle:	180°
Vertical Impact Angle:	50°
Ambient Temperature:	24.6C°
Relative Humidity:	19.5
Time of Impact:	9:45
Headform Number:	642

Impact Point Description (from lower midpoint on midsagittal line)				
On Centerline	14	<input checked="" type="checkbox"/>	mm right	<input type="checkbox"/> mm left
On Centerline	24		mm up

Free Motion HIC	570.7
HIC(d)	597.0
Impact Velocity (kph)	23.74
HIC T1 (msec)	2.8
HIC T2 (msec)	6.6

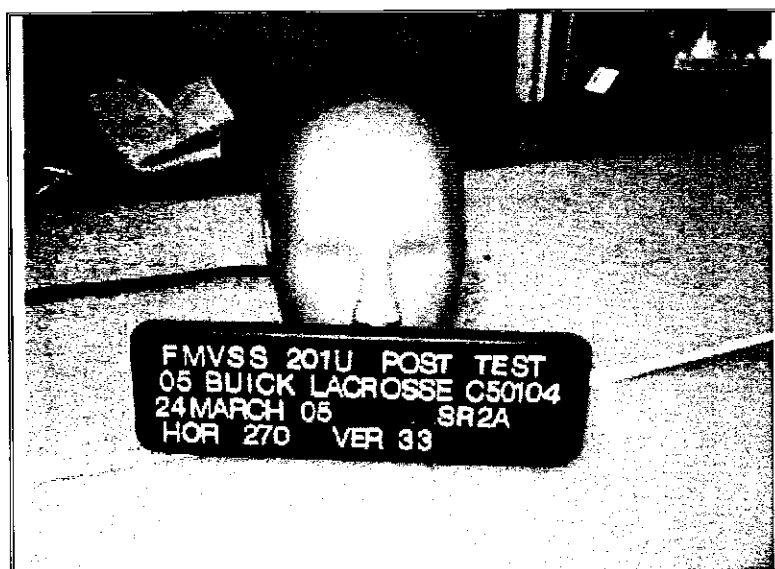
POST-IMPACT SR2A HEADFORM

Test Number:	12
Test Date:	03/24/05
Target Location:	Side Rail
Target Code:	SR2A
Horizontal Impact Angle:	270°
Vertical Impact Angle:	33°
Ambient Temperature:	24.6C°
Relative Humidity:	20.1
Time of Impact:	10:30
Headform Number:	805

Impact Point Description (from lower midpoint on midsagittal line)			
On Centerline	5	<input type="checkbox"/> mm right	<input checked="" type="checkbox"/> mm left
On Centerline	15	mm up

Free Motion HIC	820.3
HIC(d)	785.3
Impact Velocity (kph)	23.48
HIC T1 (msec)	2.0
HIC T2 (msec)	8.2
